## INTERNAL SAFETY ALERT

### Eurovia Roadstone – Fractured arm bone

Ref 038

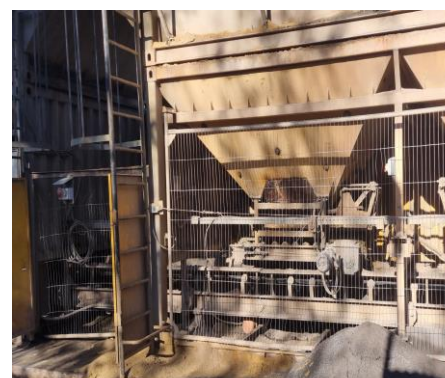
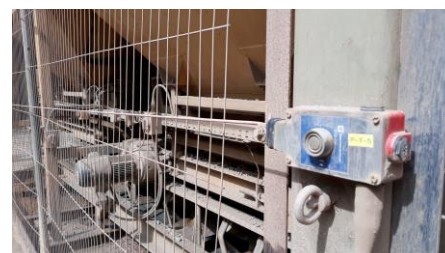
The operative had undertaken a site check, after noticing aggregate spillage around the hopper bins then returned to begin cleaning up below the cold feeds when they noticed an old section of rubber belt caught up in the main drive belt. They believed this section of belt must have been left behind from a previous belt repair.

The operative attempted to remove the section of broken belt (wedged in place), whilst pulling the belt it suddenly became free causing his arm to continue moving backwards with force and striking his elbow on the side of a protruding stub bolt attached to the side of the cold feed.

- Ensure the equipment is locked out.
- Ensure on completion of maintenance activities that all tools, equipment and materials not required are removed from the area.
- All repairs should be completed as per manufacturer specifications.
- A check should be completed to ensure the area is clear of any debris prior to refitting any guards and reconnecting safety devices.
- A final check should be carried out on any repair to ensure it is working safely before signing off as complete.
